# Examining Hermeticity of UB Packages with Lid Seal Voids

Lyudmyla Ochs

NASA GSFC EEE Parts, Photonics and Assembly Branch

To be presented at MRQW February 10, 2022

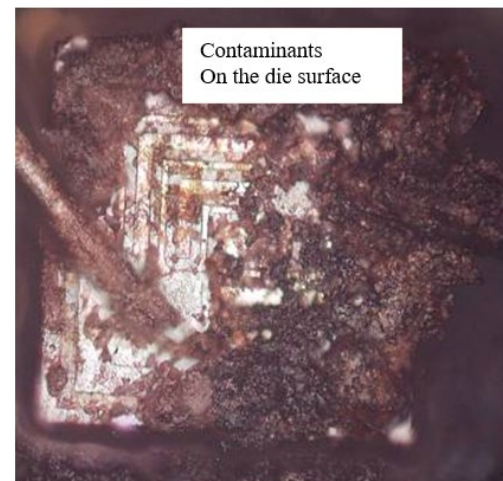
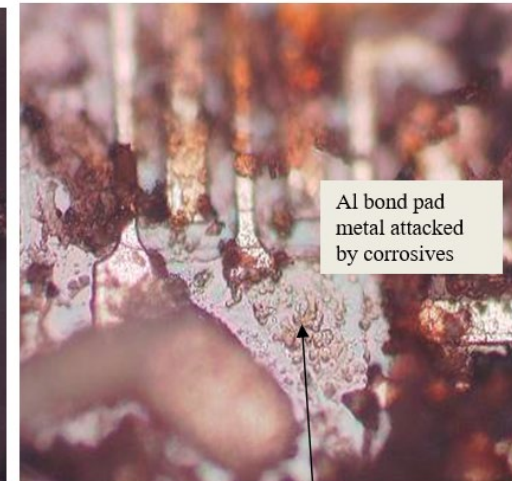
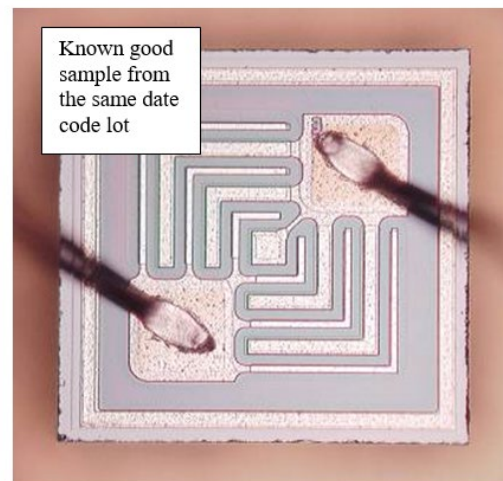
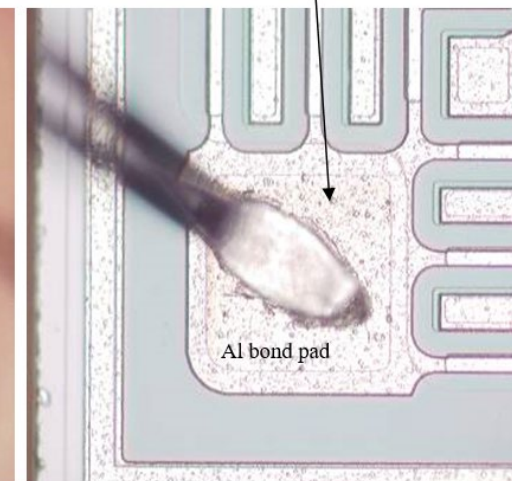
- Provided here as example of a type of failure that can occur if a package loses hermeticity
- This device package was non-hermetic, but mistakenly was placed on a board and operated
- Part operated for ~300 hours, before failing as electrical short-circuit
- Cause of failure: corrosive materials entered the package after manufacturing and during board assembly, corroding aluminum on bond pads, and developing conductive paths between collector, emitter and base

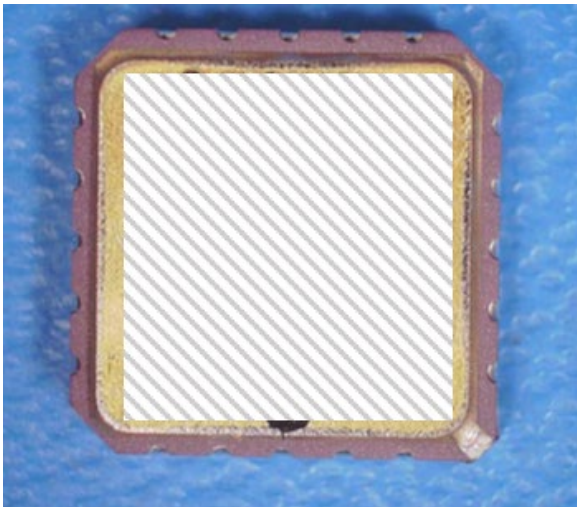
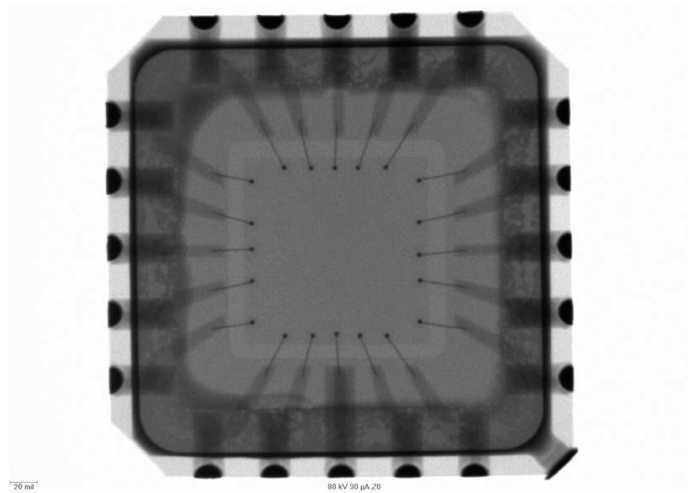
- Voids >90% of the lid seal
- Passed hermeticity
- Passed IGA

Optical image of the device (part markings removed) X-Rays of the package showing void in solder lid seal

IGA results of three packages with lid seals showing voids >90%  
IGA results show a hermetically sealed device

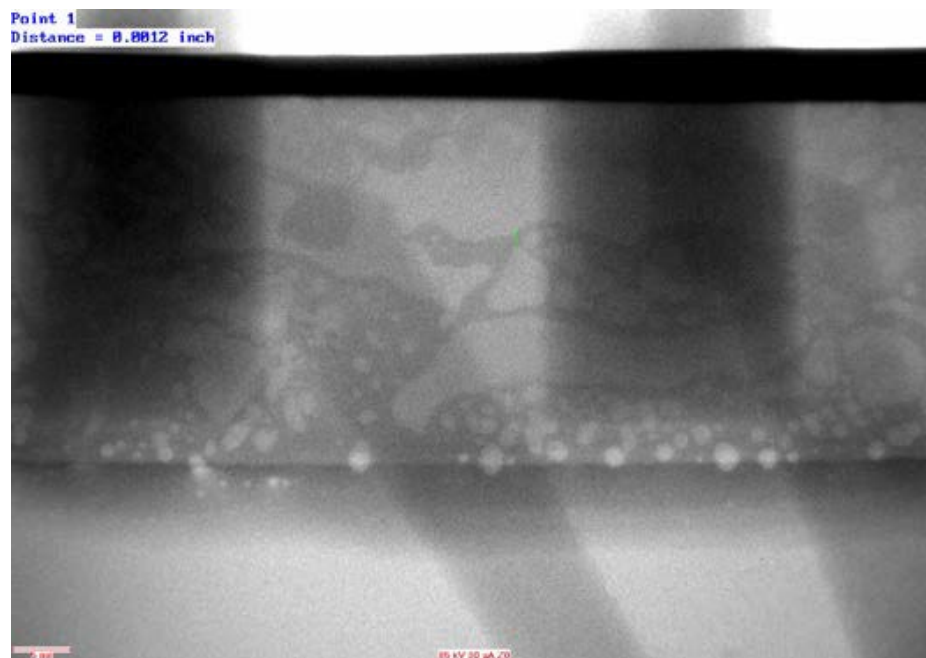
- Voids >90% of the lid seal
- Passed hermeticity
- Passed IGA

*X-Rays of the package showing void in solder lid seal. Void covers 93% of seal*

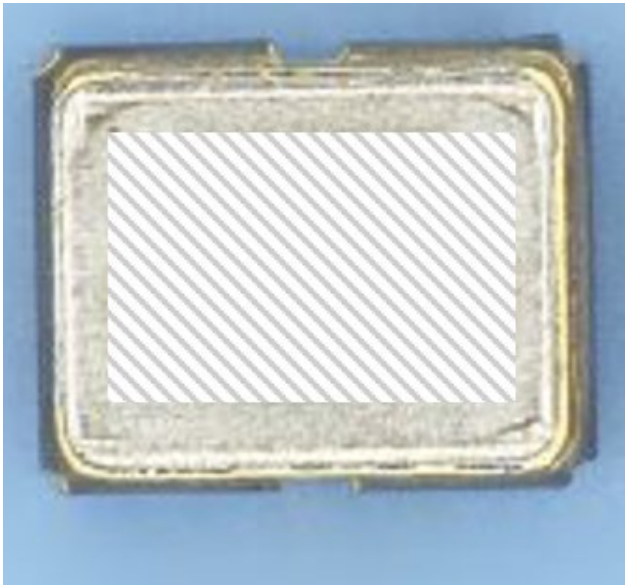
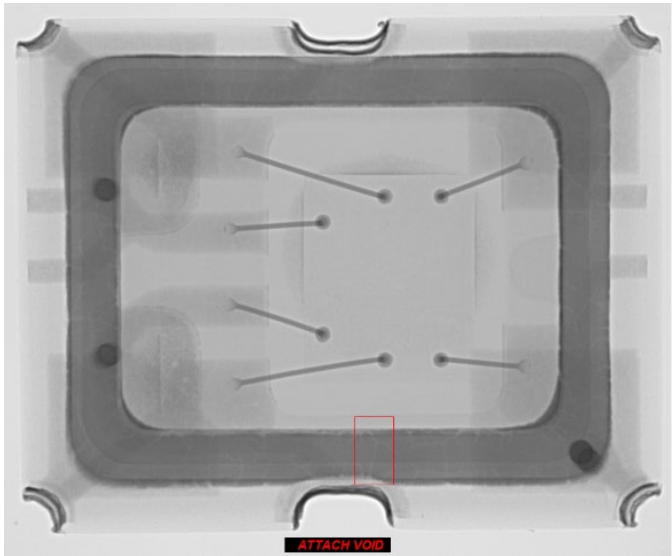
- Voids >99% of the lid seal
- Passed hermeticity
- Passed IGA

IGA results of three packages with lid seals showing voids >99%  
IGA results show a hermetically sealed device

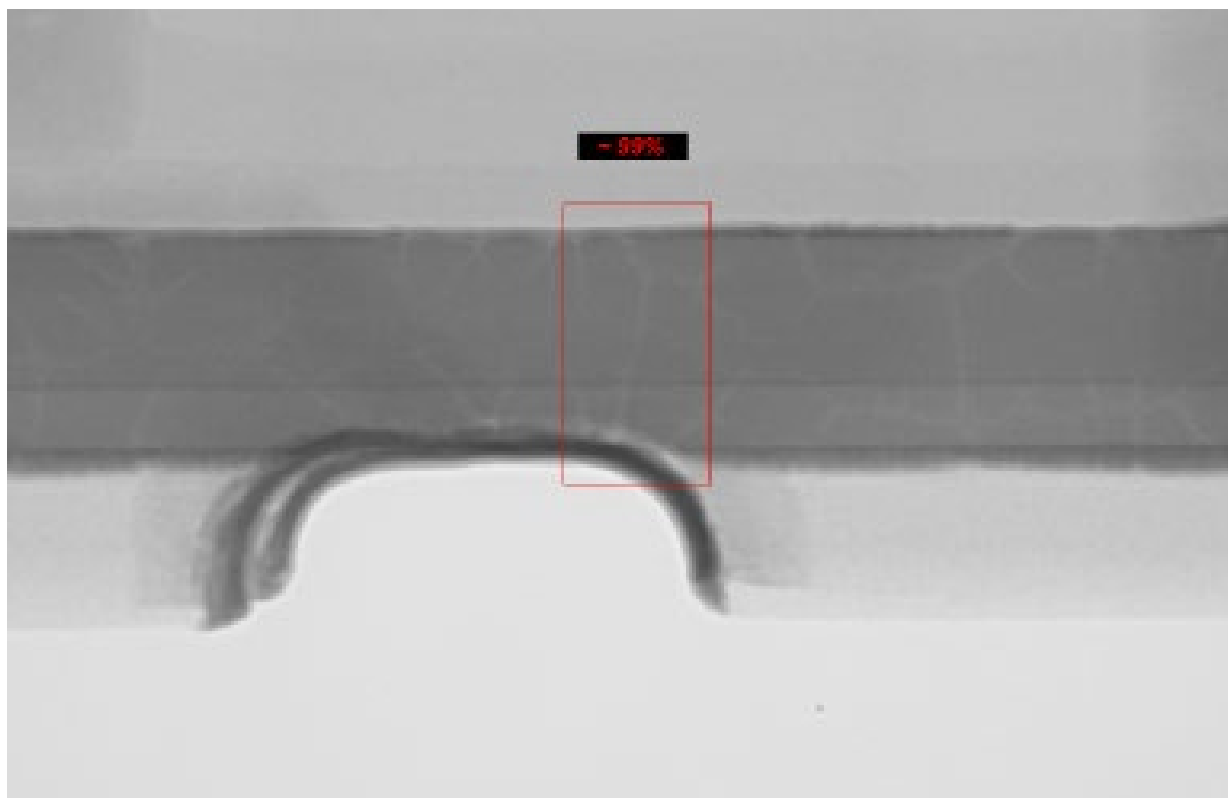
- Voids >99% of the lid seal
- Passed hermeticity
- Passed IGA

*X-Rays of the package showing void in solder lid seal*

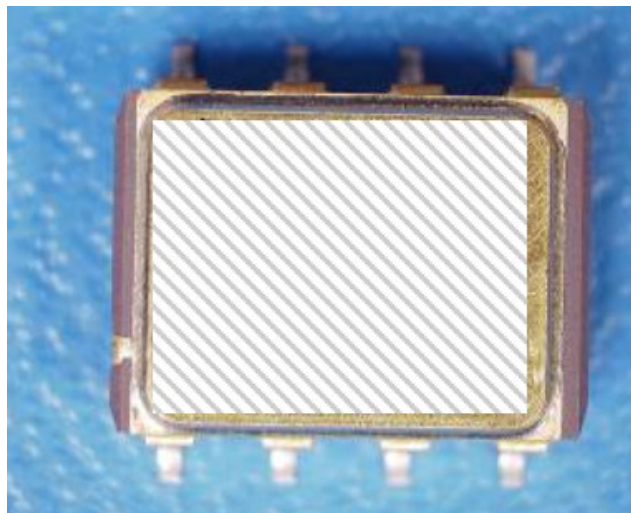
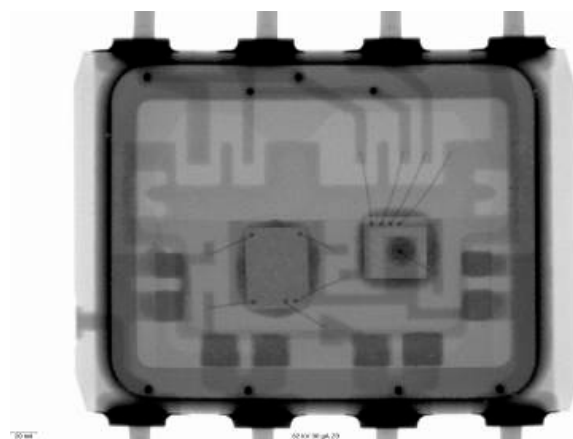
- Voids >80% of the lid seal
- Passed hermeticity
- Passed IGA
  - Note on IGA, the fluorocarbon values appear above the limit, but does not appear to be fluorocarbon ingress during gross leak testing

Optical image of the device (part markings removed)

X-Rays of the package showing void in solder lid seal

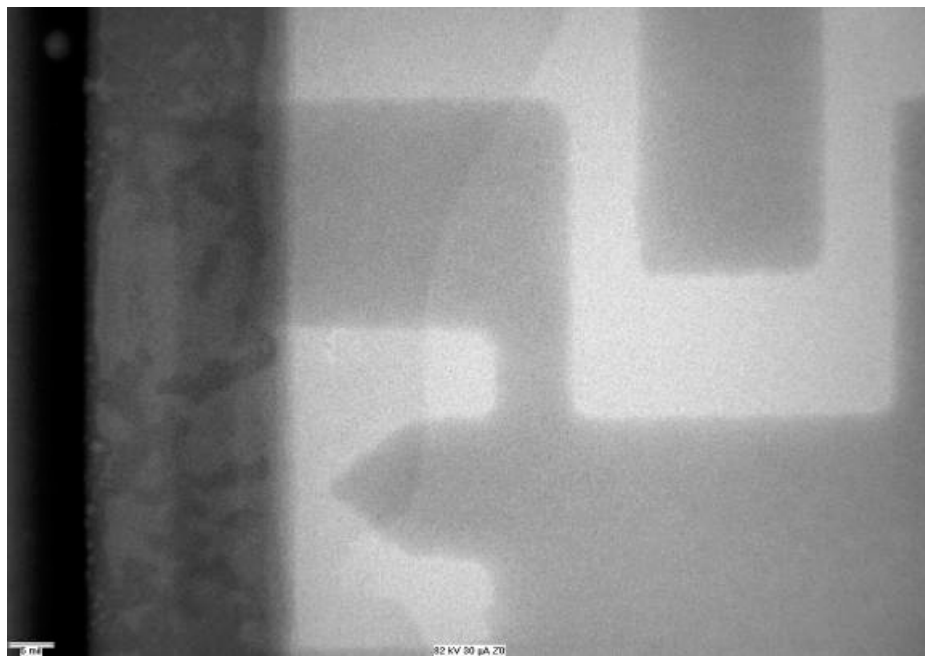
- Voids >80% of the lid seal
- Passed hermeticity
- Passed IGA
  - Note on IGA, the fluorocarbon values appear above the limit, but does not appear to be fluorocarbon ingress during gross leak testing

*X-Rays of the package showing void in solder lid seal*

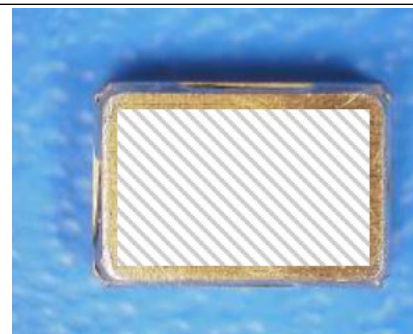
*Optical image of the device (part markings removed)*

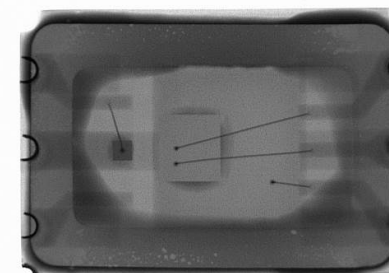
*X-Rays of the package showing void in solder lid seal*

- Background of parts
  - A commercial device screened to MIL-STD-883
  - Package style: UBA
  - Hermeticity test at manufacturer results: fine leak (147 passed/1 failed) and gross leak (147 passed/0 failures) passed.
  - X-Ray of 30 received units showed all units with lid seal voids in excess of 75%, with many units showing lid seal voids spanning 95% of the seal
- Test Plan
  - 30 units with lid seal voids in excess of 75%, and 5 control units with lid seal passing MIL-STD-883 TM2012 criteria

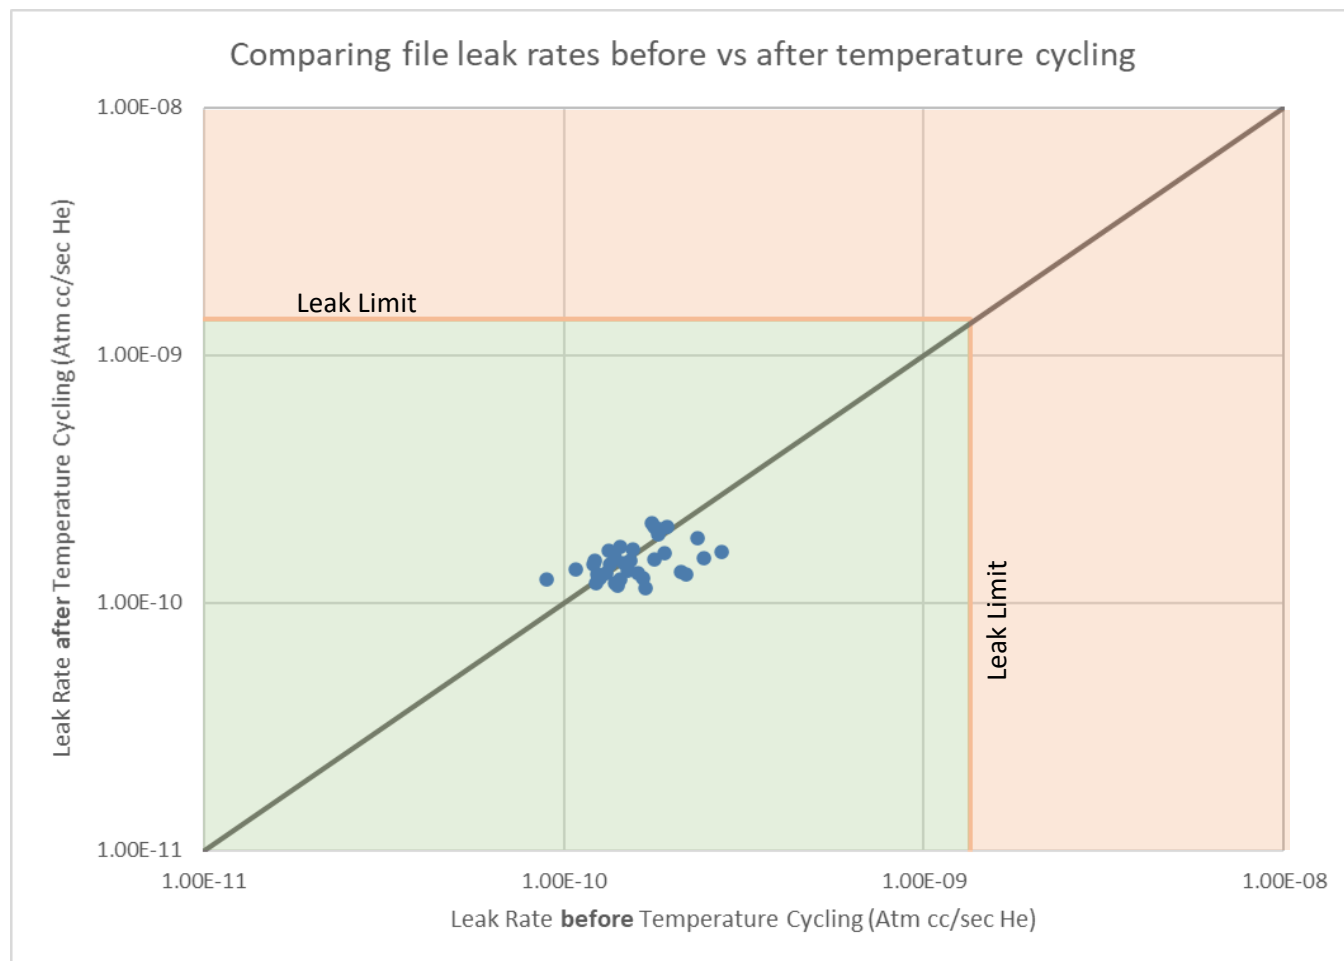
- 35 units tested for fine and gross leak before and after temperature cycling
  - 30 units with lid seal voids >75%
  - 5 units with lid seal voids <75%, as controls
- All units passed fine and gross leak before and after temperature cycling
- Fine leak measurements show consistency before and after temperature cycling
- Notes on graph:
  - Red area on the graph for leak rates failing fine leak limit
  - Green area on the graph for leak rates passing fine leak limit
  - Grey diagonal line – readings on the line mean there was no change before and after temperature cycling
